Failure analysis of 316L stainless steel crucible by molten fluoride salt interaction with clay bonded silicon carbide

Robert S. Sellers, Mark H. Anderson, Kumar Sridharan*, Todd R. Allen

Department of Engineering Physics, University of Wisconsin-Madison, 1500 Engineering Dr., Madison, WI 53711, USA

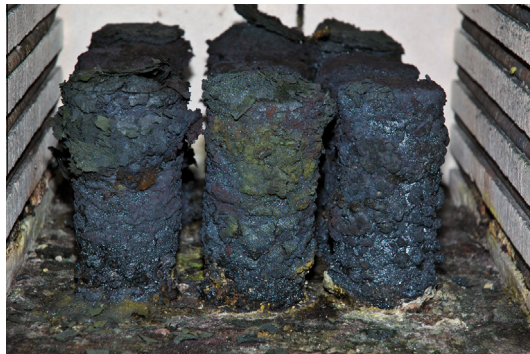
Fig. 1 shows visual characteristics of the crucibles and the high temperature electric box furnace after the termination of the test. A close up comparison of a corroded crucible and a crucible prior to testing is shown in Fig. 2. The scale formation is porous and brittle with shiny metallic sections and areas of green, white, purple, and red residue. The crucible interiors show relatively thin predominately red scale formations. Two steel sheathed type K thermocouples were used to monitor the internal temperature. Both were nonoperational due to heavy corrosion at the conclusions of the 1000 h test. The alumina sheathed type S control thermocouple remained operational the entire time and appeared unaffected. Throughout the duration of the test, the furnace was held at slight positive pressure with nitrogen cover gas making oxygen ingress unlikely.

Fig. 1. Photograph of crucibles at the conclusion of the 1000 h static test.

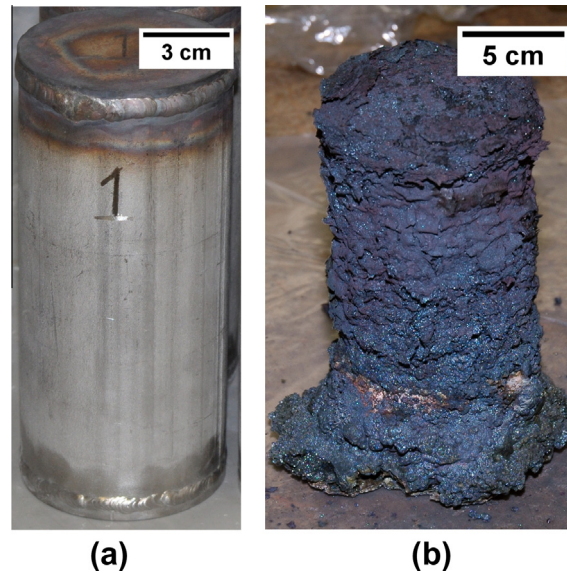
Fig. 2. A comparison of a crucible (a) before corrosion test and (b) after corrosion test. There was substantial height and radial growth of the scale.

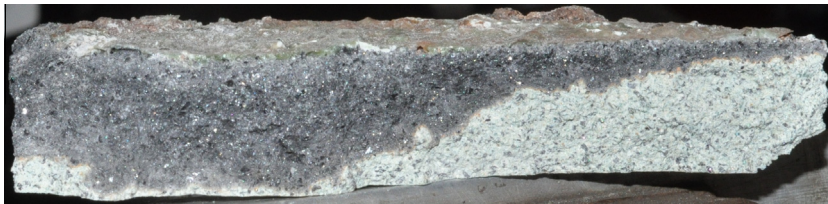
The furnace base plate, constructed of 1 mm sized particles of silicon carbide held in a clay matrix, showed extensive attack. The clay matrix is composed of minerals containing O, Si and Al. A cross section of the base plate can be seen in Fig. 3 where affected areas are discolored black. The black damaged region is accompanied by light swelling, indicative of vapor formation.

Fig. 3. Cross section of the clay bonded SiC base plate used in the high temperature furnace. Affected areas are discolored black with some associated swelling.

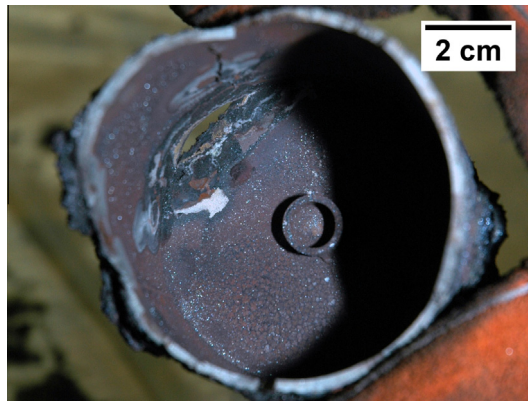
Upon inspection, it appears that the set of nine static test crucibles failed by several different mechanisms. Some crucibles exhibit circumferential cracking, shown in Fig. 4. Localized outward plastic deformation near the cracks indicates that they are stress induced. These stress ruptures are likely created by lowered crucible structural integrity caused by outward corrosion combined with internal pressurization of the argon cover gas contained within the sealed crucible. It has been shown that a structurally sound crucible is able to contain this minor pressurization, therefore this failure mode depends on the presence of corrosive vapor so stress induced cracking cannot be the method by which FLiNaK was first released into the furnace [16]. One crucible shown in Fig. 5 has a prominent failure point located at a weld joint. All failure modes considered, a faulty weld with a pinhole leak is likely the reason why FLiNaK initially escaped into the furnace.

Fig. 5. Point of failure located on the bottom weld.

1. Construct a stainless steel boat or perform the test in a retort furnace so leaked salt will come into contact with metallic components only. Such interactions are fairly well understood and vapors will not be created.
2. Minimize internal pressurization of corrosion testing vessels through hot finish welding, vacuum sealing or atmospheric vented apparatus.
3. Verify weld integrity through X-ray analysis.
4. A campaign of theoretical, electrochemical and experiential studies is required to truly understand molten fluoride salt insulation interaction. The work presented here is hindered by the need to retroactively construct a narrative using quantitative clues as opposed to a narrowly defined bottom-up approach.

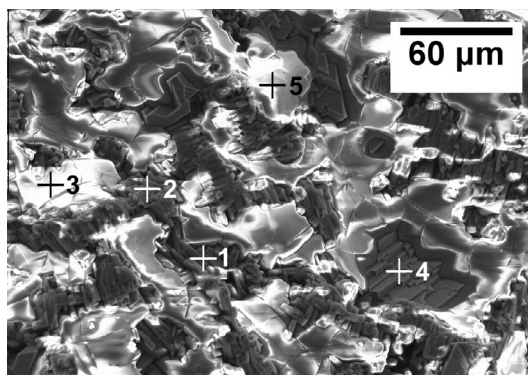
To understand the nature of the test failure, samples of corrosion crust from the top of a crucible were investigated using scanning electron microscopy (SEM) equipped with energy dispersive X-ray spectroscopy (EDS). Pieces taken from the top of the corroded crucibles display a variety of morphologies. Fig. 6 shows jagged, rough sections identified in Table 1 to be rich in O, Si, K and Fe dispersed among smoother sections composed primarily of O, K and Cr. Mixed within the jagged sections are

Fig. 6. SEM micrograph of scale topology.

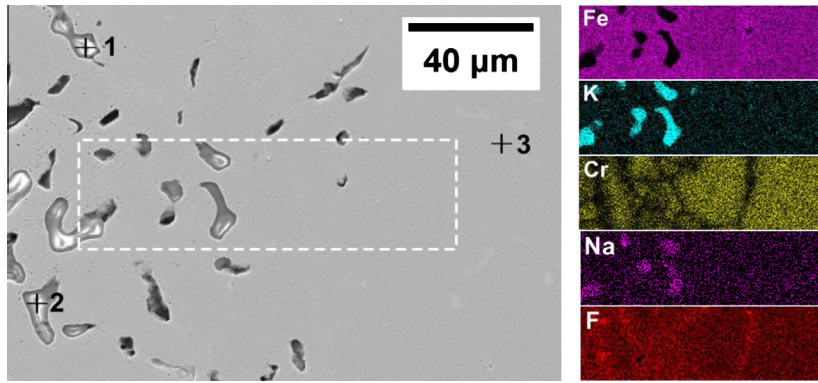
points containing only Fe and O, identified as α -Fe₃O₃ (hematite). Cross section SEM/EDS maps and point scans of the crucible wall are shown in Fig. 7 and Table 2. Depletion of iron and chromium along grain boundaries starting at the crucible exterior and moving radially inwards appears to be the main mode of attack. EDS point scans identify the F, Na, K rich compound existing between the grains as K₂NaCrF₆. XRD analysis of green substance present on the interior of the corroded crucibles provides positive identification of the presence of K₂NaCrF₆ in the test system as shown in Fig. 8. The distinct emerald green color and X-ray pattern is consistent with the description of K₂NaCrF₆ synthesized and characterized by Knox and Mitchell [17].

Fig. 7. SEM micrograph of a crucible wall cross section with the corresponding EDS map elemental distribution.

The formation of metallic fluorine compounds described by Fukumoto is consistent with the attack seen in the EDS cross sectional image of Fig. 7, where depletion of chromium and iron can be observed. Previous work has shown that chromium and iron are the most thermodynamically favored alloying constituents for fluorine attack in a 316L stainless steel system [14]. In addition, it has been shown that Iron (II) Fluoride can sublime at temperatures as low as 690°C [22]. Such a sublimation process explains the distinct iron voids in Fig. 7 as well as the porous structure of the corrosion crust whereby Iron (II) fluorine vapor pockets would exert pressure on surrounding material, causing expansion and eventual release of FeF_2 vapor. Combining the Fukumoto silicon fluoride diffusion theory with the sublimation of FeF_2 and the synergistic effects of the $\text{K}_2\text{SiF}_6/\text{Na}_2\text{SiF}_6$ vapors over hundreds of hours, it can be seen how this processes would create a porous corrosion crust that compromises the structural integrity of the stainless steel tube.

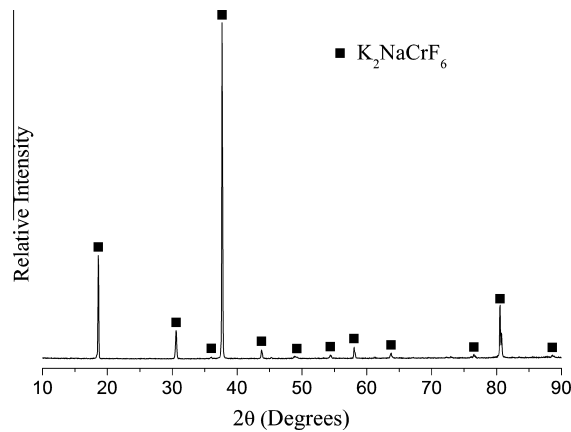
Fig. 8. X-ray diffraction pattern of green material recovered from the crucible.
